### **Validating the techno-economic viability of hemp lime construction for passive and low energy moisture control in museum storage**

A thesis submitted for the degree of Doctor of Philosophy

University of Bath

Department of Architecture and Civil Engineering

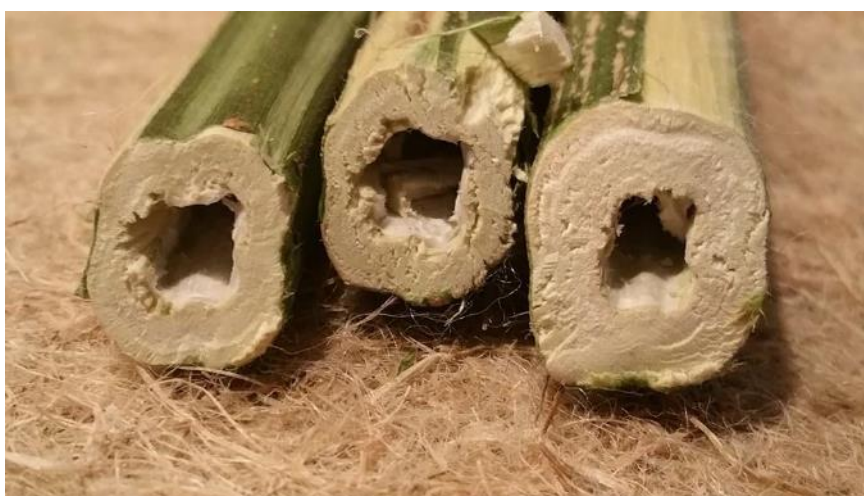
**Figure 3.13 Cross section of hemp stalk**

The hemp stalk comprises 20% to 40% bast fibre and 60% to 80% wood pith with a hollow core except at the joints (Figure 3.13). After harvesting, the stalks are retted (rotted) naturally by rain and dew or by mechanical or chemical processes to remove the fibre. The wood pith (also known as shiv, shive or hurd), a by-product of the fibre industry, is separated from the fibre during decortication (removal of bark), then shredded into chips with an average dimension of 2 cm x 0.5 cm x 0.2 cm (Cerezo, 2005). The chips, originally considered a low-value waste product of the fibre industry, have begun to be used in biobased construction materials and, by 2004, about 4% of the hemp shiv produced in the EU was used in construction (Karus & Vogt, 2004).

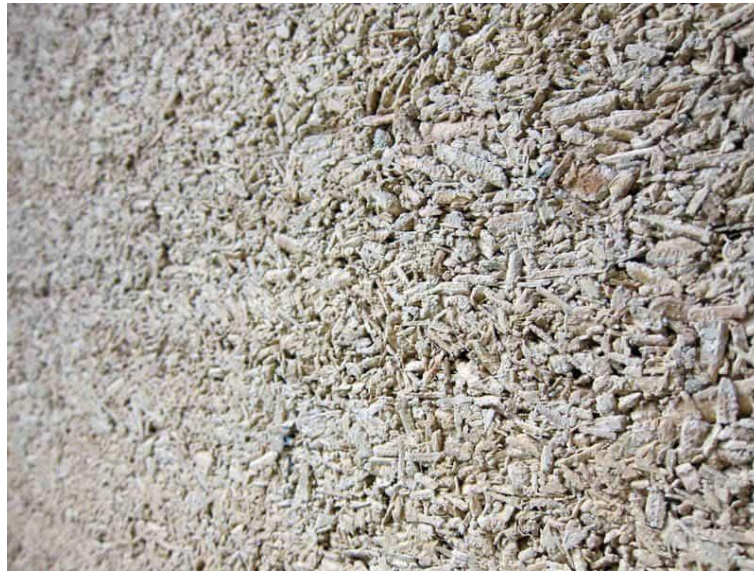
**Figure 3.15 Interconnected matrix of cast HLC**

HLC can be used to replace non-structural elements of walls that traditionally use concrete, brick, gypsum board or wood. HLC can be produced as a wet mix on site which may be cast into shuttering around framework or sprayed against a vapour permeable lining board. In casting, water is added to the dry shiv and binder before the mixture is poured and tamped into the shuttering. Spraying uses lime binder in a slurry with water forced through a nozzle to mix with shiv being blown from a separate hose. According to Bevan & Wooley (2008), spraying tends to produce a more consistent and more porous structure than casting; however Duffy et al. (2013) reported a lack of control in the consistency of sprayed HLC. Panels for insertion into framework can also be prefabricated off-site (Daly & Woolley, 2009; Jankovic, 2013). Blocks, produced either on- or off-site, can be self-supporting but are also generally inserted into a supporting frame structure (Arrigoni et al., 2017). The ultimate desired result is a very porous material, an interconnected matrix of various sizes of thinly coated shiv particles, with strong bonds between the particles only where they touch,

leaving air voids between the particles (Figure 3.15)

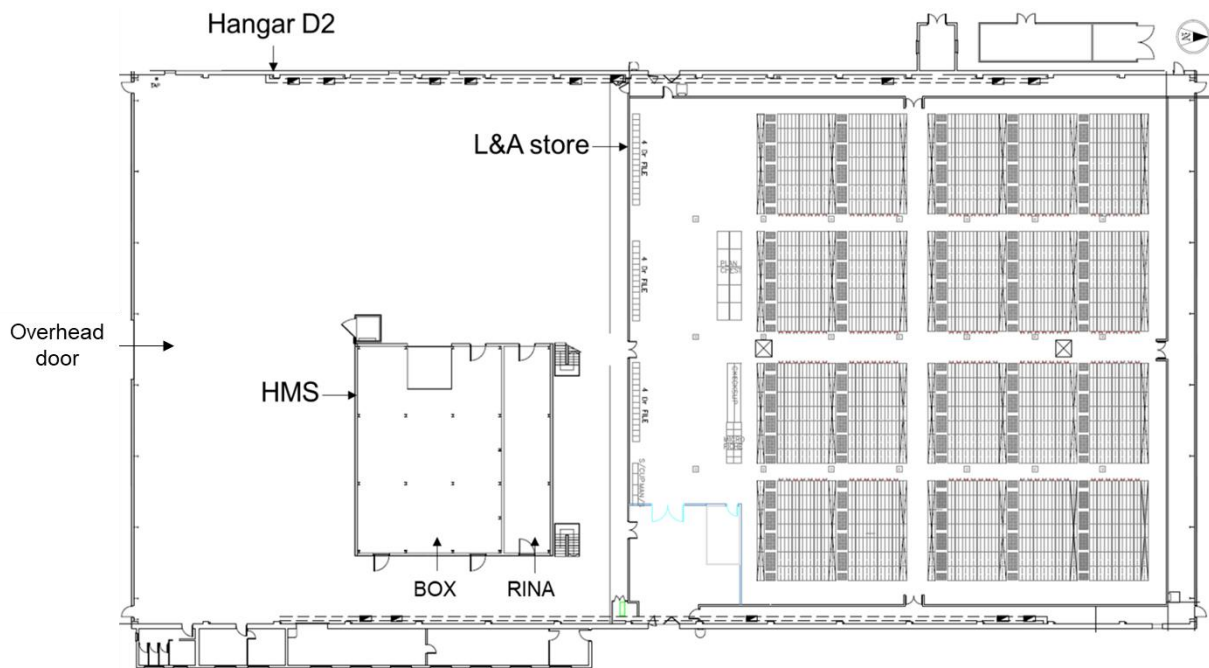
**Figure 4.2 Location of the HMS within hangar D2**

The 17.92 m x 17.15 m building was erected in the south-east area of hangar D2 (Figure 4.2). A previous low energy storage repository for the SCM Library and Archives (L&A) (discussed in section 4.4.2.2) had been built in the north half of the hangar a few years previously. Construction within another structure was intended to provide an additional layer of protection from the elements. Specifications for the store were for a stable RH and temperature suitable for the storage of highly

The building was positioned next to the L&A store, being oriented with room access at the centre of the hangar and perpendicular to the hangar's south external sectional overhead door. Access to each of the three larger storerooms was through a sectional overhead door as well as a personnel door at the front of the building, with a fire exit door, or in the case of the ground floor two fire exits, at the rear. The three smaller rooms had a personnel door at the front and a fire exit at the rear.

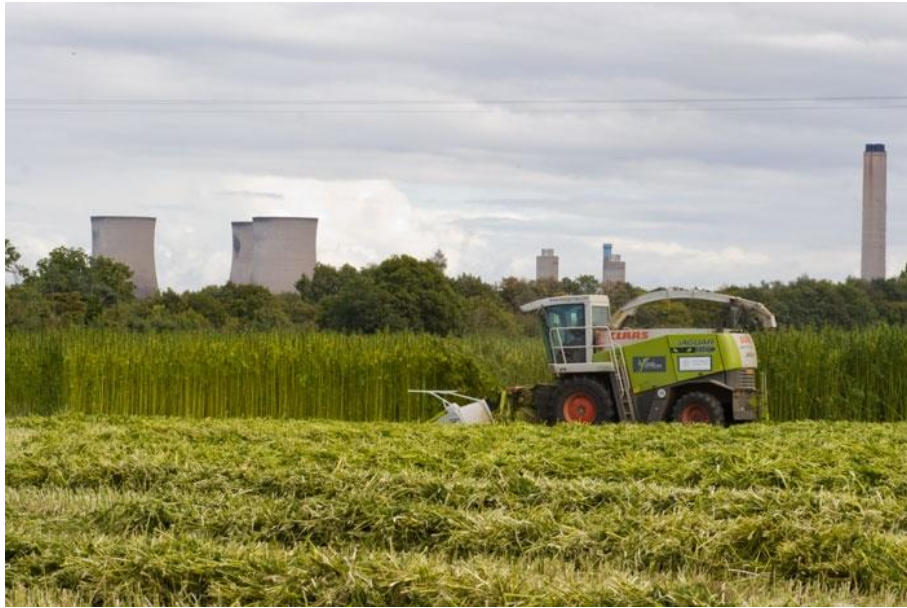
**Figure 4.4 Industrial hemp grown in Suffolk for Tradical® HF**

Tradical® HF, an aggregate produced from the stem of industrial hemp grown in the UK (Figure 4.4), was processed for construction purposes by removing the fibre, then chopping, grading and de-dusting the shiv (Figure 4.5).

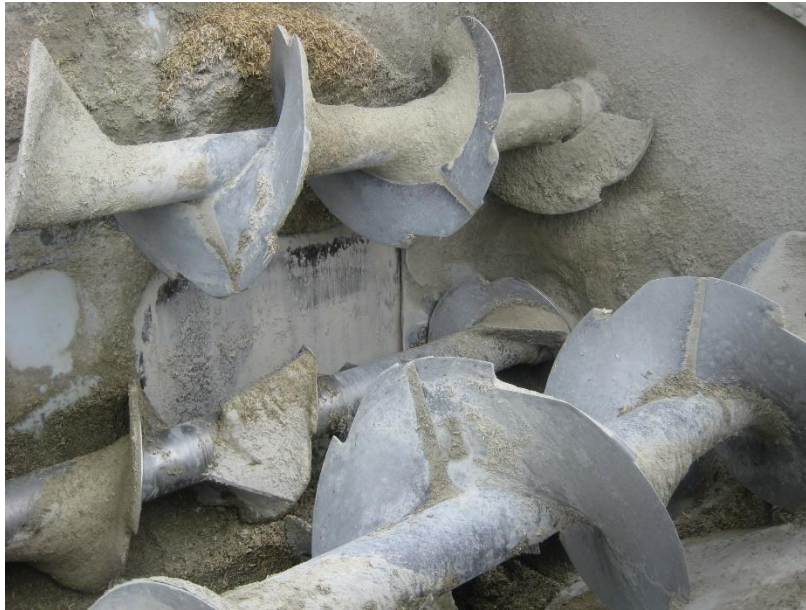
**Figure 4.6 Mixing shiv with binder**

This was then mixed with Tradical® HB, a pre-formulated binder based on a high purity hydrated lime blended with cement (hydraulic lime), pozzolanic and mineral additions, and water to produce Tradical® Hemcrete® (Tradical, 2014) (Figure 4.6).

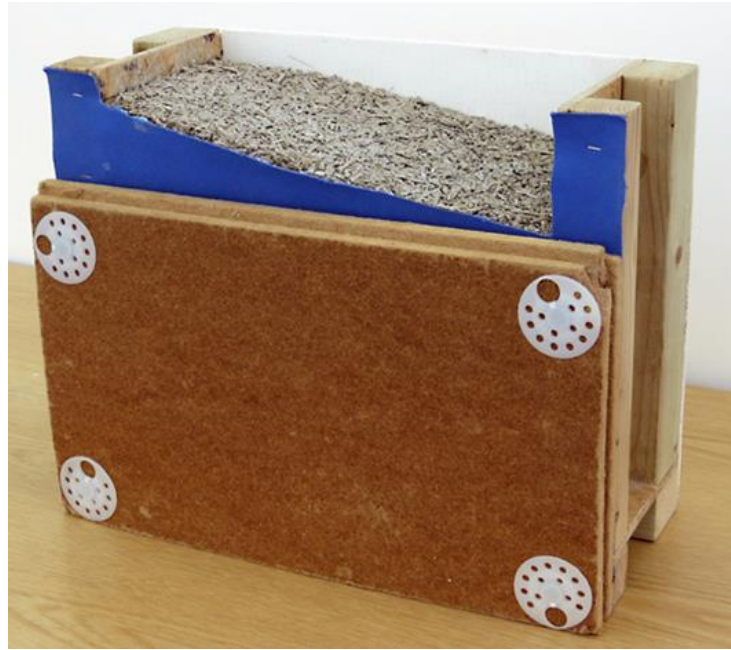
**Figure 4.7** Example section of the modified exterior wall panel

The panels used to construct the store walls were a modification of the pre-cast wall product Hembuild® (Appendix C), produced by Lime Technology. The standard wall system incorporates internal softwood timber studs within a timber cassette formed from a Glulam base and head member and plywood side pieces. 9 mm thick Multi-Pro XS Board, a white medium density magnesium silicate fire retardant board, is used for the inner face. Manufactured from inorganic minerals ( $\text{SiO}_2$ ,  $\text{CaCO}_3$ ,  $\text{MgO}$ ,  $\text{MgCl}_2$ ) and fibreglass mesh, Multi-Pro XS has an A1 fire rating, low thermal conductivity, moisture and water resistance, rodent and mould resistance and breathability (Resistant Building Products, 2015) (Appendix C). 120 mm of Tradical® Hemcrete® (Appendix C), with a density of  $330 \text{ kg/m}^3$  (Tradical, 2014) is cast against the Multi-Pro XS, then 90 mm to 180 mm Breathe™ hemp fibre insulation and a breathable airtightness membrane added. A cladding system completes the outer face.

The panels used for the storage building were modified by increasing the thickness of Tradical® Hemcrete® to 195 mm and eliminating the insulation layer as the emphasis was to be on greater humidity control than temperature regulation (Pritchett, (*pers.comm*), 25.02.2014). Panels used for the interior walls were lined on both sides with Multi-Pro XS which eliminated the need for plastering and painting. Panels used for the exterior walls were lined on the outer face with a breathable airtightness membrane (Figure 4.7; Figure 4.10). Testing based on *BS 476: Part 22:1987* for fire resistance integrity achieved 88 minutes for the exterior panels (BRE Global test report number 269397) and 180 minutes for the interior panels (BRE Global test report number (269398).

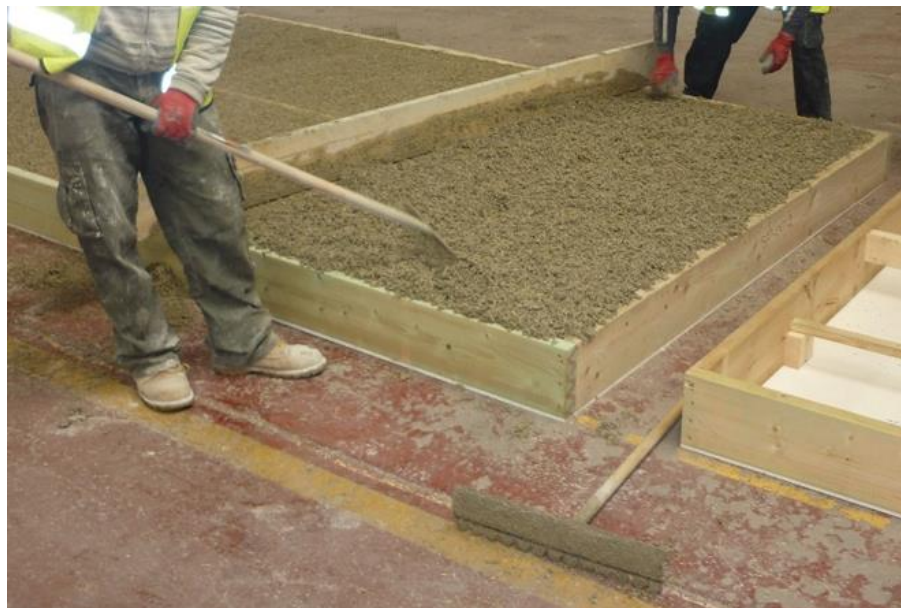
**Figure 4.8** Finishing off process for cast panel

After casting and light tamping to finish the exterior face (Figure 4.8) the HLC panels were air-dried for several days (Figure 4.9).

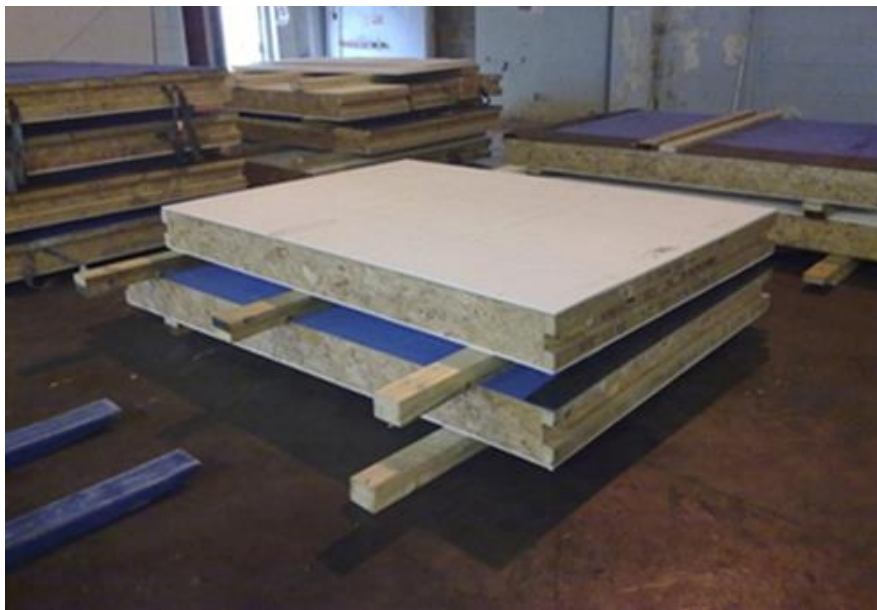
**Figure 4.10 Completed exterior and interior wall panels**

A total of 742 m<sup>2</sup> HLC panels were used, 606 m<sup>2</sup> for the external walls and 136 m<sup>2</sup> for the interior walls. Panels were given a U-value of 0.22 W/m<sup>2</sup>·K.

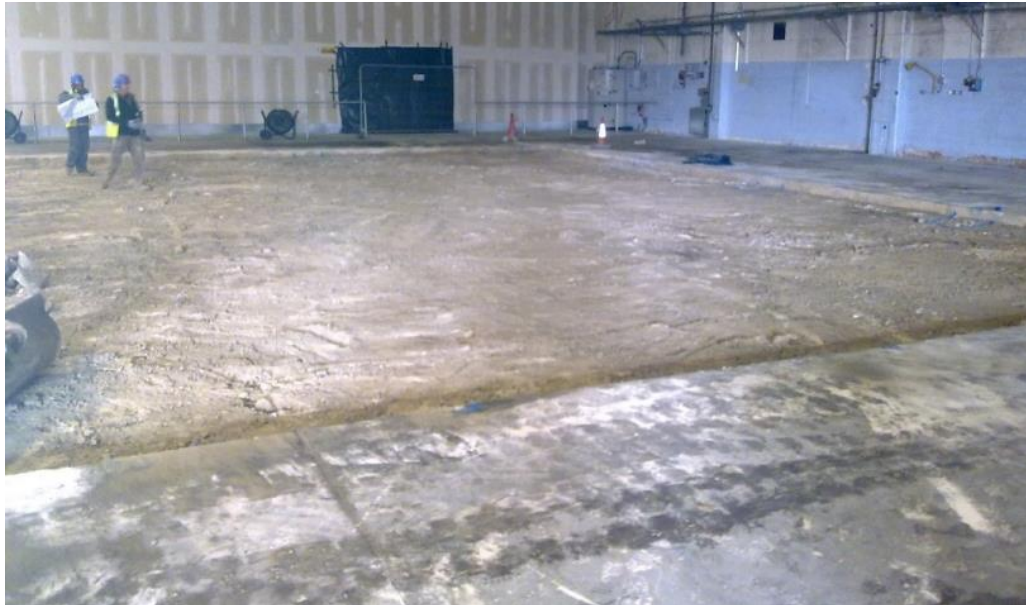
**Figure 4.11 Groundworks for HMS foundations & floor slab**

In order to support the high floor loading required for archival storage as specified in *BS 5454:2000* (10 kN/m<sup>2</sup> to 12 kN/m<sup>2</sup>), groundworks were required to cut a 17.88 m by 18.78 m hole out of the existing concrete floor slab (Figure 4.11) to allow foundations to be laid on the harder chalk soil found approximately one metre below the slab. Column pads were founded on the firm chalk at a minimum depth of 1150 mm with foundation trenches dug at a minimum depth of 875 mm. An initial layer of 25 mm sand, followed by a layer of 100 mm rigid insulation (Celotex rigid polyurethane foam) sandwiched between 1000 gauge damp proof membrane was

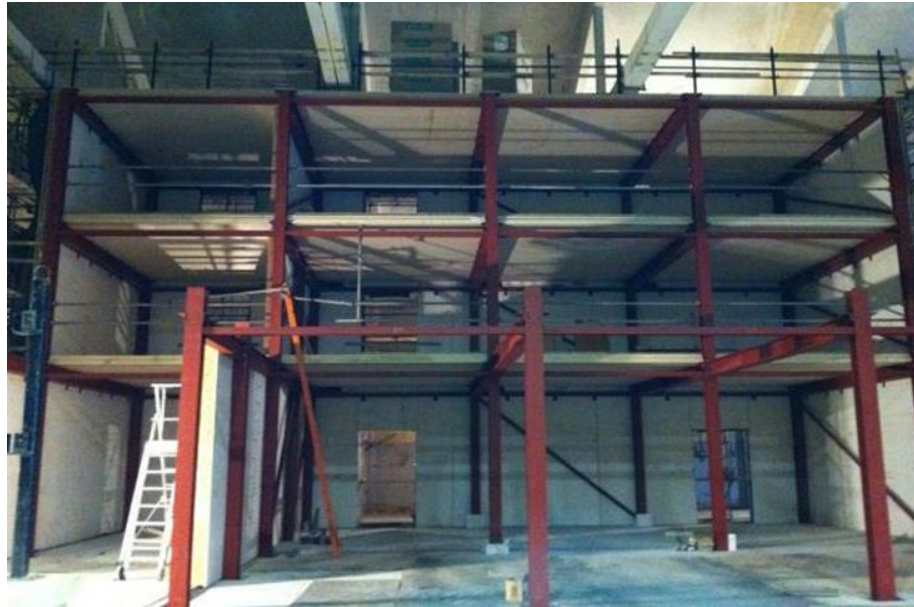
**Figure 4.13 HLC panel installation on steel framework**

The prefabricated panels were used to clad a three-storey high steel superstructure (Figure 4.13). They were slotted into place then tied back to the steel frame with coach or wood screws. The structural steelwork used universal beams (UB) and

universal columns (UC) for the framework with circular hollow sections (CHS) used for bracing. The steel framework was coated with intumescent paint.

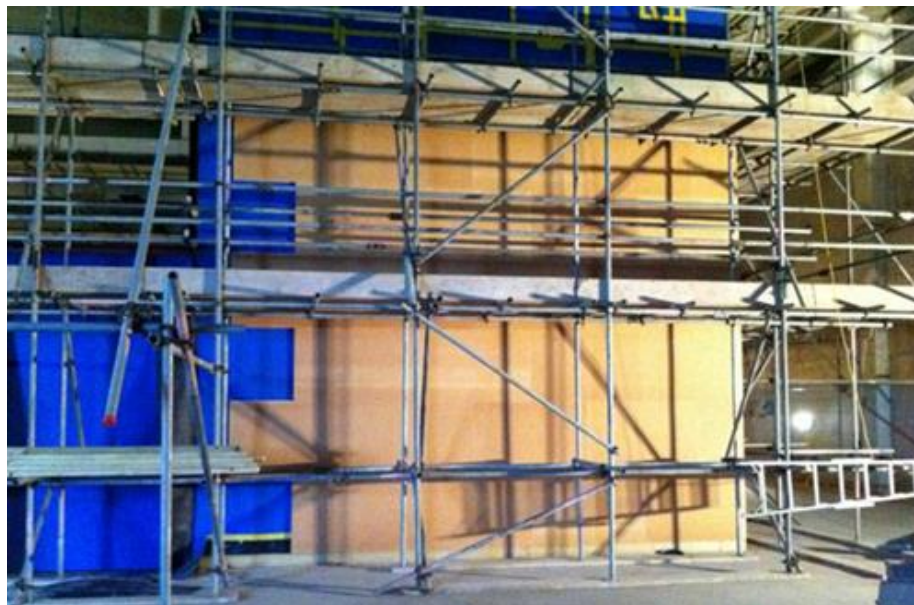
**Figure 4.14 External cladding of wood fibre insulation board**

All paper joints and laps were sealed with 60 mm wide breather membrane (Siga Sicrall) lap tape to enhance airtightness. Interior joints were faced with additional strips of Multi-Pro (Collins, 2012). The HLC panels were externally clad with a layer of vapour permeable 80 mm thick Pavatex (Hofatex® Therm) (Appendix C) wood fibre insulation board (Figure 4.14) and a layer of 'rat mesh' (Figure 4.15).

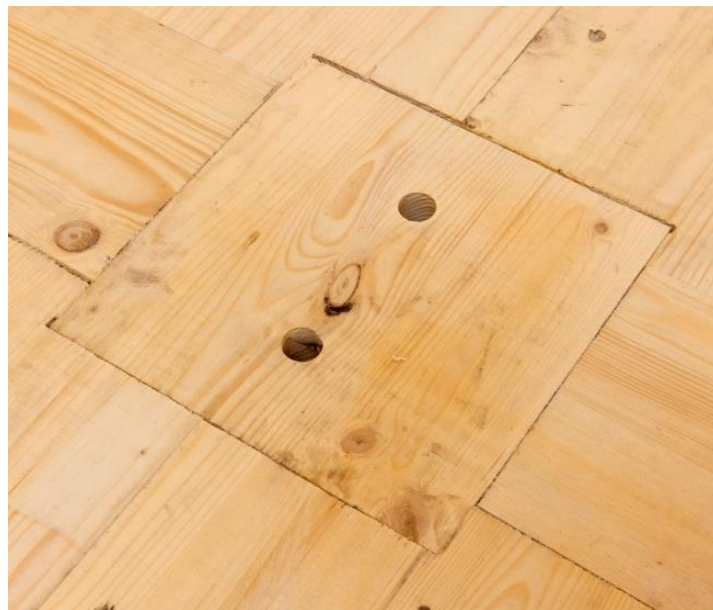
**Figure 4.17 CLT intermediate floor with floor cap in place**

Intermediate floors were formed using sustainably-sourced spruce 162 mm thick CLT planks, chosen for high structural strength, excellent dimensional stability and vapour permeability, to span the structural steel beams. In order to increase floor-standing space in the BOX storerooms, the floor weight specification was reduced and access spaces left for future installation of additional steel columns were capped (Figure 4.17). After installation, the CLT planks were treated with Envirograf Product 92 clear fire protection coating (Appendix C). As no information on vapour permeability is available, its use likely affected the vapour permeability of the CLT, reducing potential buffering.

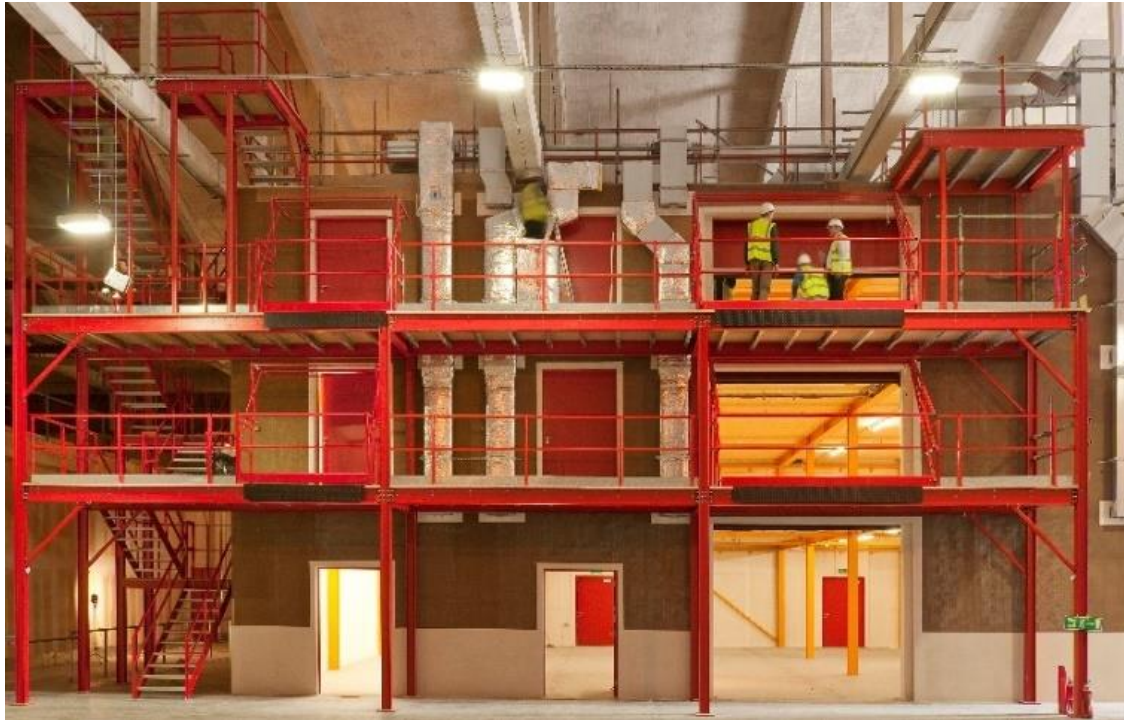
**Figure 4.18 Front face of the HMS with external access framework & doors**

Access to the upper storerooms was provided via external free-standing steel frame staircases, one at each north corner of the building, with steel frame balconies floored with insulation board (Powerdeck). Each BOX room had a personnel door and sectional overhead door at the front and a rear fire exits (two fire exits on the ground floor); each RINA room had a personnel door at the front and a fire exit at the rear (Figure 4.18); all doors opened directly into the hangar. Doors were edged externally with Multi-Pro board strips for wall protection. Gates were inserted into the railings of the decks in front of each store on the first and second floors to allow archives and objects to be delivered on pallets using a reach truck. A small lift, suitable for conveying art works and archival material, was later installed at the SW corner

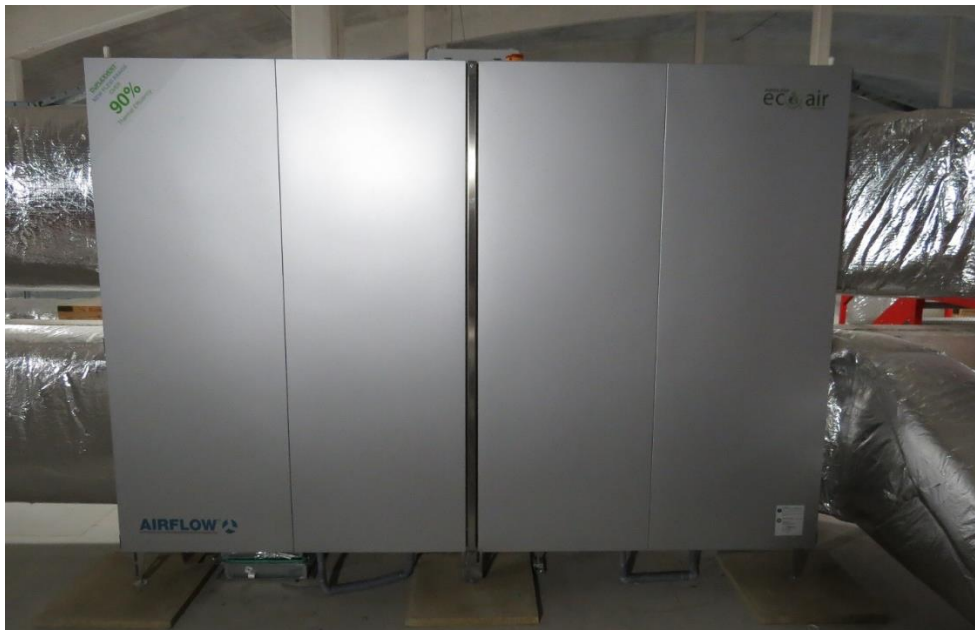
**Figure 4.21 AHU1-FF, unit supplying HMS 1, 2, 3 & 4**

separate ducting system but this was altered in the final design as a result of value engineering undertaken during the final design review. Two mechanical ventilation heat recovery units with cross flow plate heat exchanger were installed on the roof of the building with one handling the ventilation to HMS 5 and 6, the other to HMS 1, 2, 3 and 4 (Figure 4.21). A schematic of the MVHR unit is provided in Figure 4.22. Breakdown costs of the total M&E system, including design, installation of equipment and environmental monitoring, are given in Table 4.2. Costs of the M&E system accounted for not quite 10% of the total project costs.

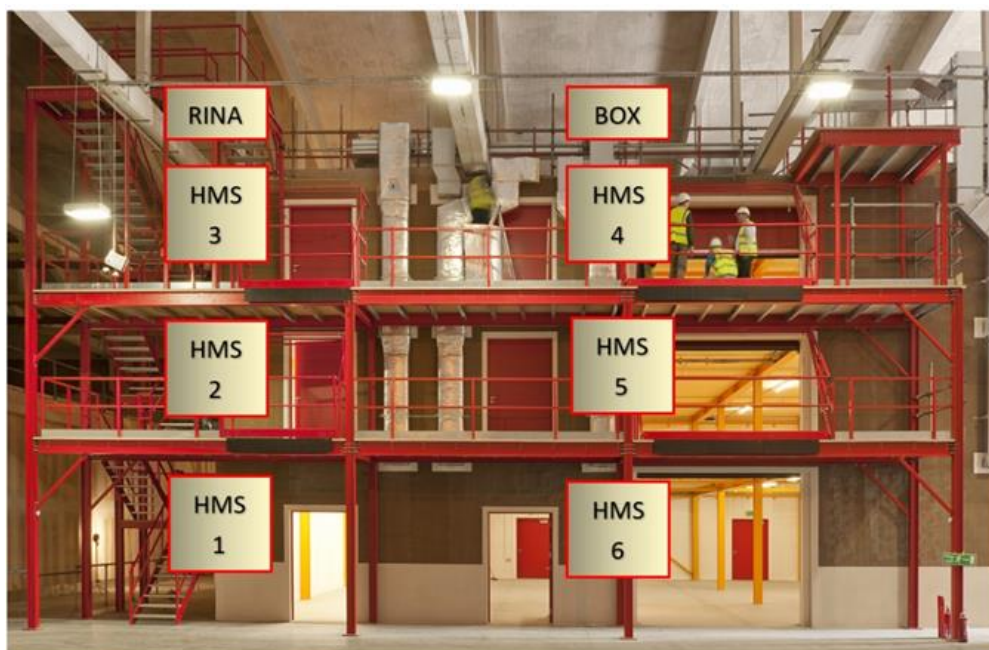
**Figure 4.25 Completed building showing location codes**

After construction was completed, the storerooms were given location codes in the collections management database (Figure 4.25). The three RINA rooms were numbered HMS 1, 2 and 3, from ground to second floor. The three BOX rooms were numbered HMS 4, 5 and 6 which fortuitously followed the AHU zoning.

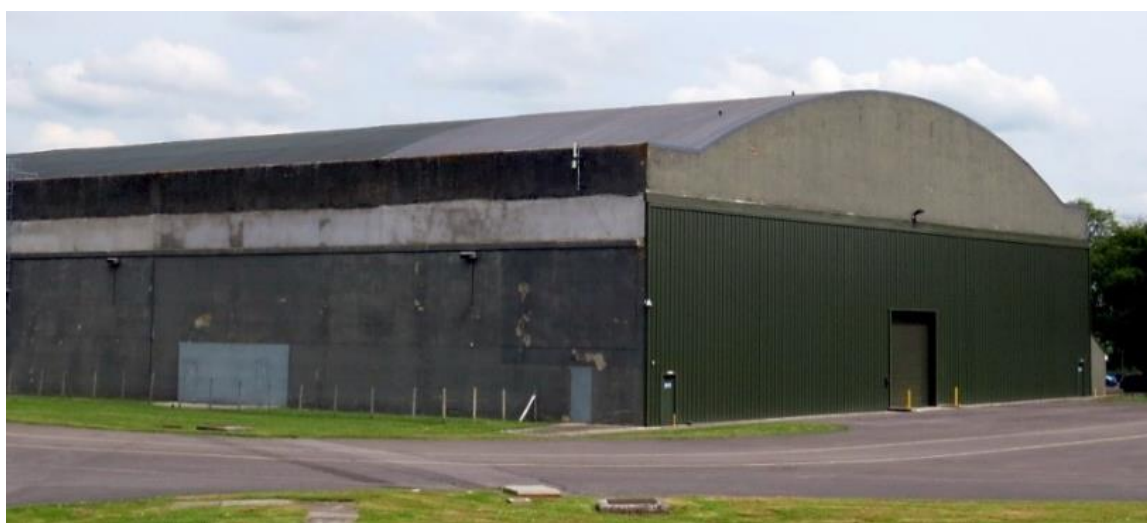
**Figure 4.26 South end of hangar D2 with completed renovations**

Refurbishment to the hangar had occurred in two phases. The first, undertaken in 2006, was limited to cleaning the interior, removing asbestos cladding and lead paint, and sealing shut the north hangar doors. In 2011, the hangar doors at the south end were replaced with 81 mm Kingspan KS1000RW composite wall panels (50 mm insulated core; U-value 0.38 W/m<sup>2</sup>K) (Appendix C) and a sectional overhead door. The hangar doors at the north end were removed and the space filled in with Kingspan panels. Door projecting rails were removed as was the asbestos-clad annex on the west side. The windows were blocked in and some concrete repairs undertaken (Figure 4.26). The roof was not replaced nor was there any additional insulation added to the walls or ceiling. Subsequent to the refurbishment, wire mesh was attached over the external face of all the walls due to continuous spalling of the concrete exterior. While both phases of refurbishment were enabling works for the construction of, firstly, the L&A store and, secondly, the HMS, the costs of neither phase were included in the capital costs for the storage building projects.

The original hangar heating system had been made redundant in 2004 and was not replaced. There was therefore no mechanical control of RH. The thermal mass of the building was inadequate in mitigating the external environment to meet SMG requirements as the building only afforded protection from wind, rain and extreme external conditions. RH levels averaged between 60% RH and 75% RH in summer to 75% RH to 90% RH in the winter.

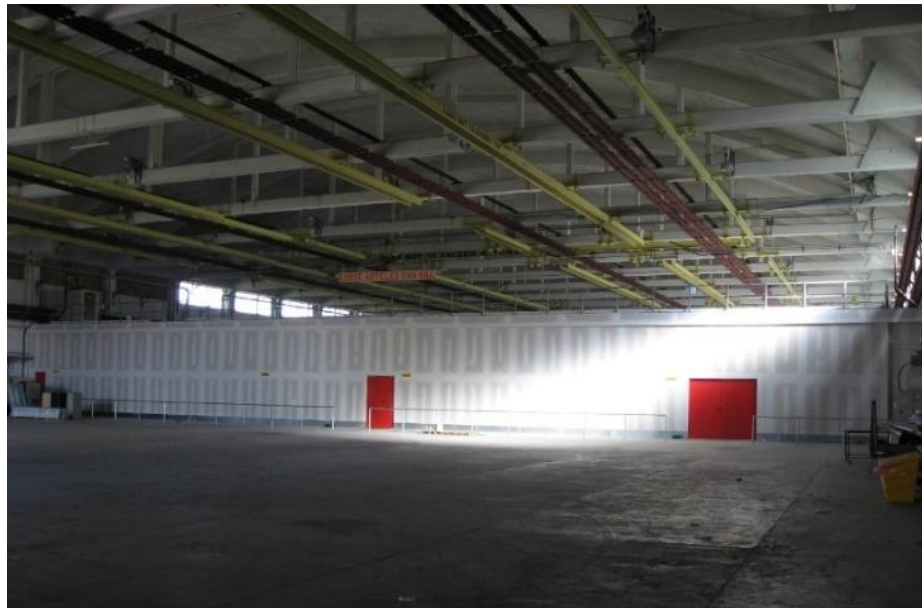
**Figure 4.27 South end of L&A store, in hangar D2**

The free-standing structure had a service/ fire corridor running around the perimeter on three sides, with fire exits on the south face from the entrance vestibule and the store itself opening directly into the hangar (Figure 4.27; Figure 4.28).

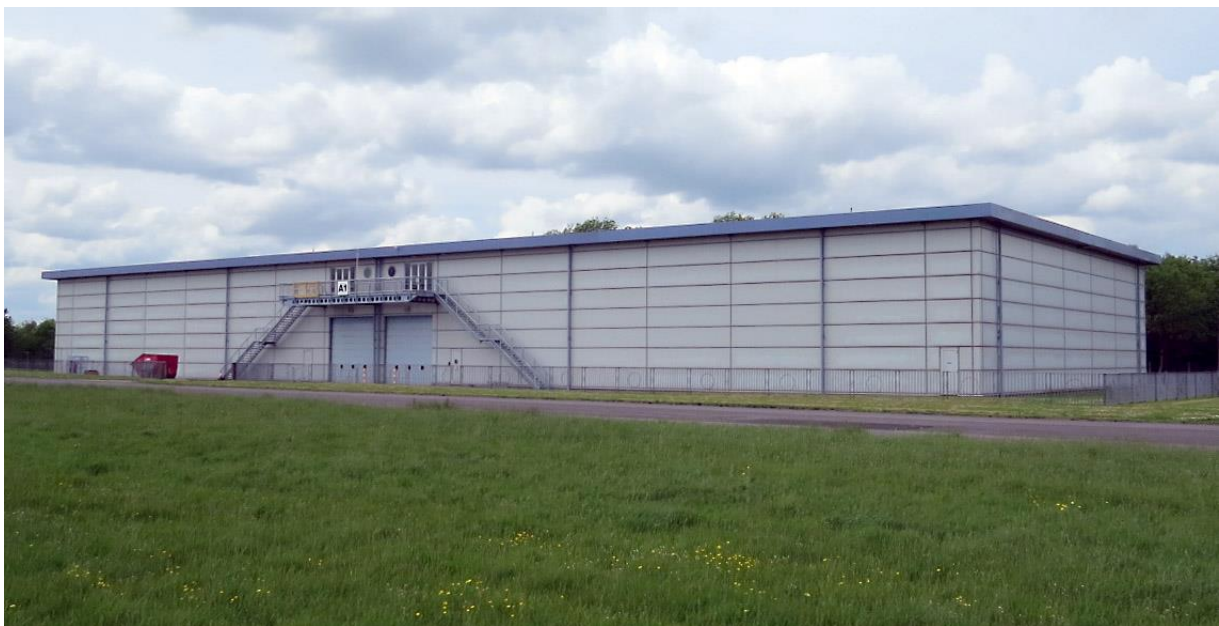
**Figure 4.29 Front face of the A Store**

The only free-standing purpose-built storage building on site, the A Store was built in 1992-1993 at the north end of the NCC site, at a cost of £2.9 million, to hold medium-sized scientific and industrial heritage collections (Figure 4.29). It consisted of a 35 m by 90 m by 10 m high insulated (68.6 mm polystyrene) structural steel frame set on insulated concrete pad bases with double polythene damp proof membranes, with external horizontal composite cladding panels hung on the mainframe and mullion supports from ground to roof. It had a flat steel deck roof with a single ply synthetic felt membrane laid over insulation and a vapour retardant. There were two large storage areas on either side of a central loading and reception area. The outer double loading bay had two overhead sectional doors to outside and one overhead sectional door to the inner reception bay. Overhead sectional access doors, one on either side of the reception bay, led into the two stores. There were two mezzanine floors, one at the front of the building with office (converted to textile storage in 2010) and welfare spaces, and one at the back, with two AHUs and a cooling and humidification (steam)/dehumidification (desiccant) plant. Another plant room for two oil-fueled boilers and one AHU was located on the ground floor, to the rear of the reception area and below the mezzanine plant room. The finished building envelope had an area of 3,150 m<sup>2</sup> and an overall volume of approximately 32,000 m<sup>3</sup>. Just over two-thirds of the volume could be considered usable storage space, with the two main stores each being just over 11,000 m<sup>3</sup>. The two ground floor stores were furnished with eight metre high racking, 28 rows of mobile pallet racking on the west side (A1) and 10 rows of static pallet racking on the east side (A2). A floor plan is presented in Chapter 6, Section 6.3.2. Airtightness testing by BSRIA was reported by Laurin & Scott (1994) to show an excellent air-leakage rate performance based on BSRIA standard of 2 m<sup>3</sup>/(h·m<sup>2</sup>) @ 50 Pa but no figures were recorded. Infiltration rate was set at 0.15 air changes/hour in the stores (Read, 2011).

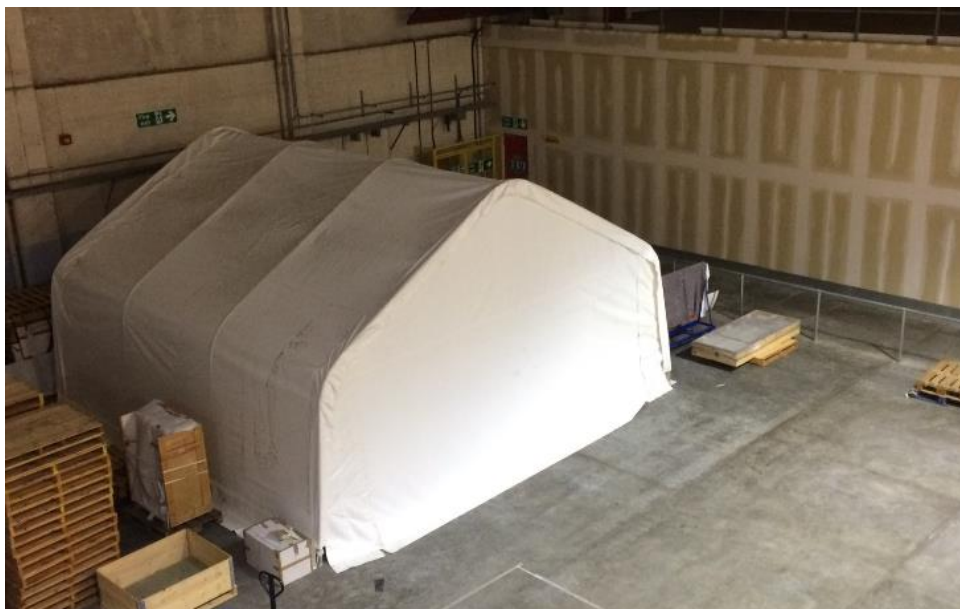
**Figure 4.30 Free-standing collections storage shelter in D2**

shelter was erected next to the library and archive store and across from the HMS. The 7.3 m d x 7.3 m w x 4.2 m h unit had a galvanised steel frame with a heavy duty 610 g/m<sup>2</sup> polyvinyl chloride (PVC) cover and a large roll-up door which could be more or less sealed shut using a velcro strip system (Appendix C) (Figure 4.30). The storage shelter in hangar D2 was unheated and without dehumidification so objects remained wrapped for additional protection.

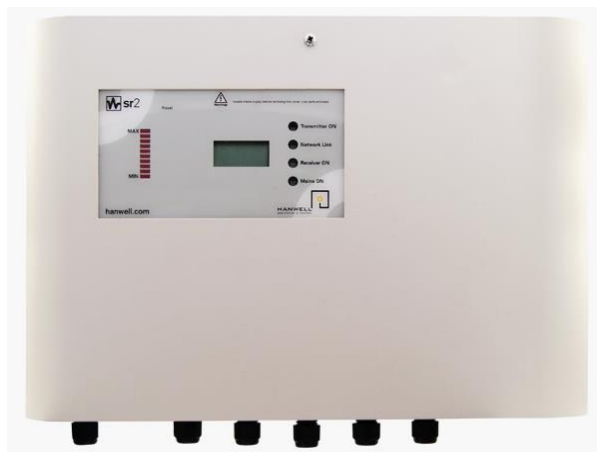
**Figure 4.31 SR2 receiver (Hanwell, 2018)**

A Hanwell Pro network-enabled smart base station receiver, SR2 (Figure 4.31), which collects and logs environmental monitoring data from multiple points within a site or across multiple sites, was connected to a 240V AC power source in HMS 5 and to the SMG environmental monitoring system via a local area network (LAN) point.

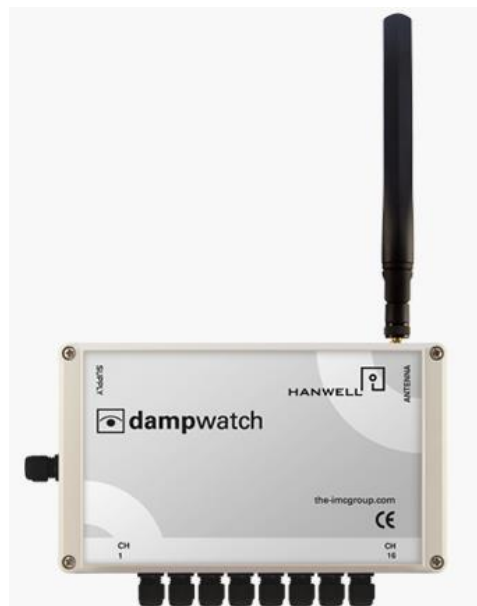
**Figure 4.33 Dampwatch unit (Hanwell, 2018)**

In 2017, a moisture detection unit was added to the HMS monitoring programme, in order to see if a relationship between levels of internal RH and the moisture content within the HLC matrix could be determined. The Hanwell 16 Channel WME Sensor Unit (Dampwatch) (Figure 4.33), operated over a range of -20°C to +65°C in a non-condensing RH environment. The unit accepted up to 16 dampness sensors. However, sensors were not provided with the purchase of the unit and so this researcher manufactured sensors in-house. Internet research provided a blueprint (Frueh, 2017).

The Dampwatch unit uses construction industry-recognised Wood Moisture Equivalent (WME) measurements. WME is the moisture level in any building material as if it were in close contact and in moisture equilibrium with wood, expressed as percentage moisture content, MC (%), of wood (Figure 4.37). The construction industry uses the percentages from a generic wood as a relative scale. The Dampwatch sensor unit measures the resistance between the pins and converts the resistance value into the water content of beechwood. The water content levels are relative rather than actual as the theoretical WME is unlikely to be the same as the actual water content of the specific material being monitored (Hanwell, 2018).

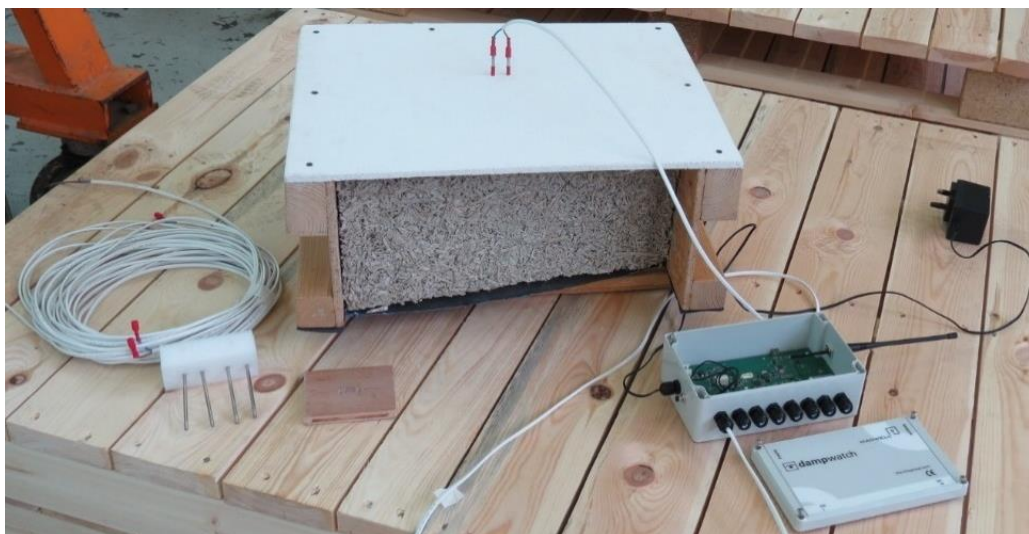
**Figure 4.35 Components for sensor trials**

A template was made for drilling holes in the HLC walls to ensure the pins were inserted 20 mm apart (Figure 4.34). A marker made from red insulation tape was placed on each pin to ensure the pins were inserted 50 mm into the HLC matrix. A trial was run using the HLC exterior wall sample (Figure 4.35; Figure 4.36) under varying ambient humidities in the conservation facility, ranging from 30% RH to 70% RH. The trial proved that the sensors were sensitive enough to provide data to the unit.

A 4 mm diameter stainless steel rod was cut into pins 100 mm in length, slightly sharpened on one end to facilitate insertion into the HLC walls, the other end keyed to allow soldering. Two pins were attached to a length of two core braided copper wire insulated cabling. The initial attempt at soldering the pins to the copper wire was not very successful given the small size of the wire and difficulty in soldering to stainless steel, with a propane torch being required to achieve the correct temperature. Instead, 4 mm red female bullet connectors were used as they fitted the pins perfectly and provided a secure push fit connection. This made a more user-friendly product as one end of a pin could be inserted into a connector after the other end was inserted into a wall. Their continuity was tested with a multimeter and was found to be good. The wire was soldered to the bullet connectors as well as crimped for the best connection. Making the sensors in-house allowed cable lengths up to a

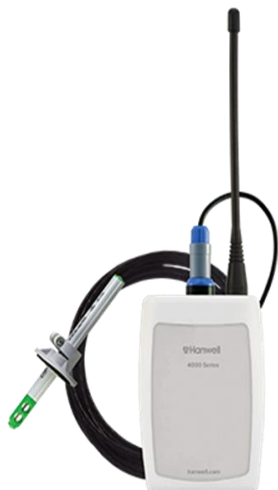
**Figure 4.39 Air flow transmitter & sensor (Hanwell, 2018)**

An ML4810 air flow transmitter (Figure 4.39) was added to the Hanwell monitoring system in the HMS in 2018 to identify operational problems with the air handling system. It was thought that data might also be used to identify the effects of ventilation on storage environment although, typically, air flow meters are used to

monitor air flow levels and alerts for door openings/closings and HVAC systems operation/failure. The data produced from the air flow meter was mapped to the data from the RH/T transmitters to see if a correlation could be made between an increase in RH fluctuations and an increase in ventilation rate.

Three probe operating ranges were available, with decreasing accuracy with increasing working range. The air flow sensor option J189-0, with an operating range of 0-10 m/s, accuracy  $\pm(0.3 \text{ m/s} + 4\% \text{ of measuring value})$ , was picked as its supplied cable was of sufficient length to enable the sensor to be suspended from the ceiling. The sensor was a thermoelectric (hot-wire) anemometer probe which produces accurate data when measuring low air velocity in the range 0 m/s to 10 m/s, making it suitable for use inside museum stores.

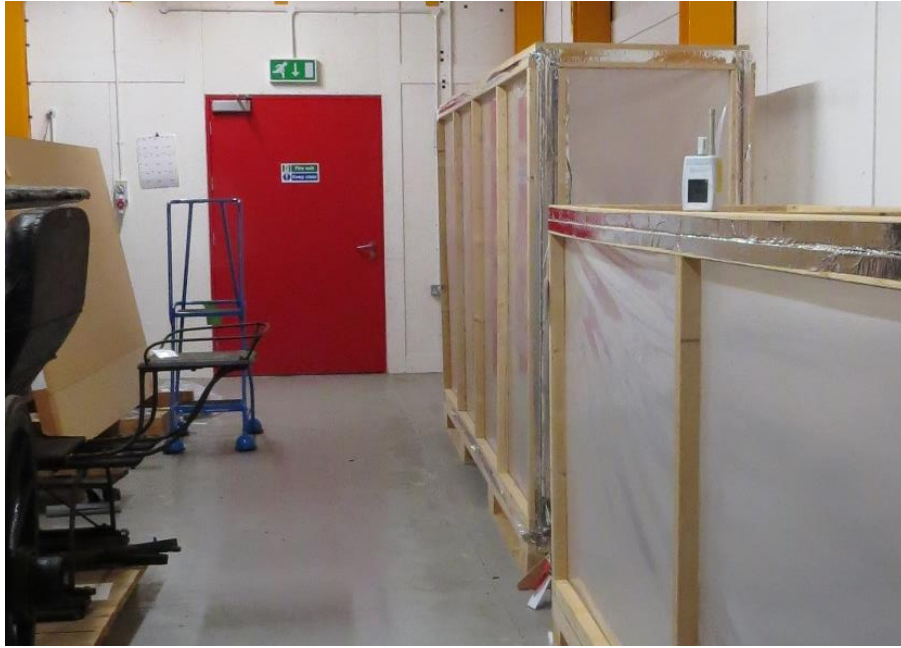
**Figure 4.40 ML4106 unit location, HMS 6**

At the start of the transient period, a Hanwell ML4106 RH/T transmitter unit was placed on the floor of each of the empty BOX storerooms (HMS 4, 5 and 6), against the internal (north) wall in order for the site conservators to monitor the ambient storage environment before delivery of any collection objects. As storage furniture and objects were installed in the rooms, the three units were repositioned within the same areas. In HMS 5 and 6, they were placed on top of conveniently located ship model crates, at 1400 mm above the floor near the centre of the north wall (Figure 4.40; Figure 4.41). In HMS 4, the sensor was placed on the central flange of the art racking framework, on the north side of the centre aisle at a height of just over 1000 mm (Figure 4.42). Unit locations were not identical in each storeroom due to storage furniture and object placement within each room but were as close as practicable. The units remained in these locations throughout both phases of the research project in order to retain consistency of data.

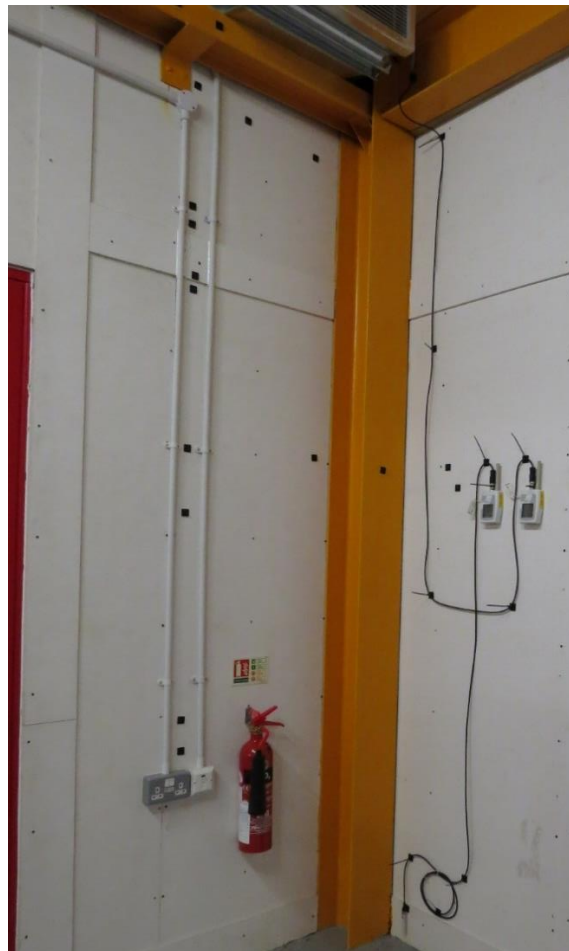
**Figure 4.46 ML4114 unit & sensor locations, HMS 6**

Two ML4114 RH and temperature units were installed in January 2018 in the north-west corner of HMS 6. Three metre probe extension leads allowed one sensor to be installed just above floor level and one at the ceiling height of 3080 mm, in order to collect data on potential stratification of RH levels and fluctuations (Figure 4.46). Positioning was due to the location of carriages and ship model crates in the room. The probe at ceiling height was placed to the side and slightly behind the supply vent in order to reduce any effects of direct air velocity on the sensor. Data was compared to that from the room's median ML4106 RH and temperature unit.

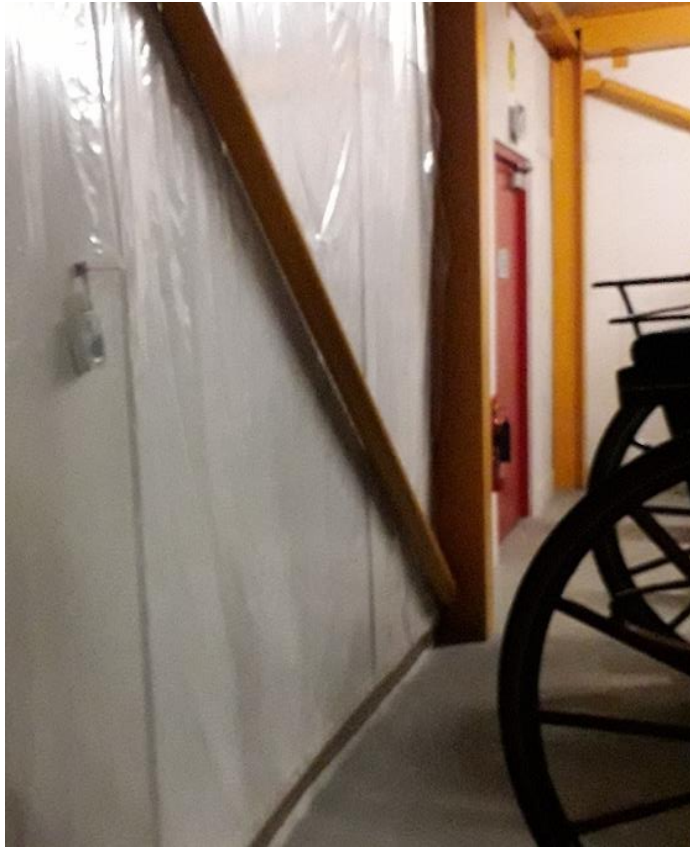
**Figure 4.47 ML4106 unit location, under polythene, east wall HMS 6**

From August 2019, an ML4106 unit was positioned on the east wall of HMS 6 at the same height as the median sensor and sealed over with a section of polythene (Figure 4.47). This provided data for a definitive comparison between the response of RH within the room and within the HLC wall as a result of internal and external influences, in order to clarify the dynamic influence of the HLC.

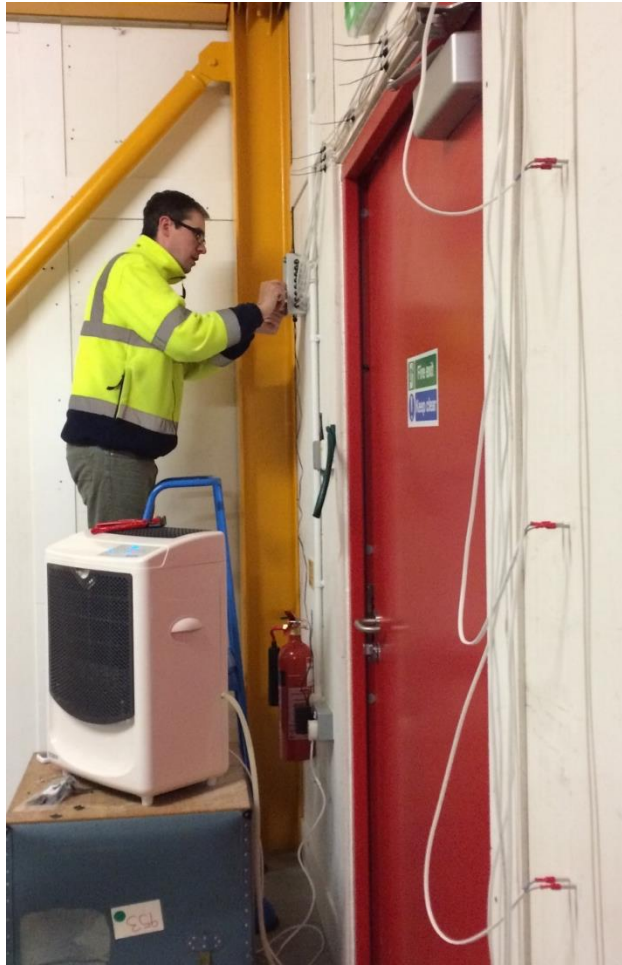
**Figure 4.48 Installation of Dampwatch unit & sensors, HMS 6**

The 16 channel Dampwatch moisture detection unit was installed in HMS 6 (Figure 4.48) in April 2017, to determine if there was a relationship between the moisture content, MC (%), of the HLC walls and the room RH. The 16 pairs of sensors were inserted into the HLC walls at the north-east corner of the room with half the sensor pairs inserted into the east wall and the other half into the north wall. The area was chosen as access to both interior and exterior walls was not hindered by carriages or ship model crates. Pairs of sensors were installed 20 mm apart at intervals of 410 mm, with sensors **1 to 8** from floor to ceiling on the east exterior wall and **9 to 16** from floor to ceiling on the interior north wall.

Sensors could not be inserted directly at ceiling height due to the steel framework of the building so the highest sensors were inserted at 280 mm from the ceiling, just under the ceiling beam. The lowest sensors were inserted 160 mm from the floor. Sensors were inserted 50 mm deep through the Multi-Pro XS facing boards and into the HLC walls. Holes only had to be drilled through the Multi-Pro board as the pins could then be pushed into the HLC matrix. This gave the pins enough contact with the HLC to ensure good thermal conductivity and uniform heat transfer. Sensors were sealed into the holes using the cable bullet connectors and the cables were run to the Dampwatch unit mounted on the east wall.

Usable data was acquired from the Dampwatch from August 2017 once operational diagnosis identified that the Dampwatch sensor reading and transmitting intervals had been set incorrectly. Once the reading and transmitting intervals were corrected, consistent readings were obtained. Data was assessed to see if changes in internal or external RH levels had a reciprocal effect on MC (%). Data was also evaluated to see if moisture transfer had any effect on RH levels or fluctuations.

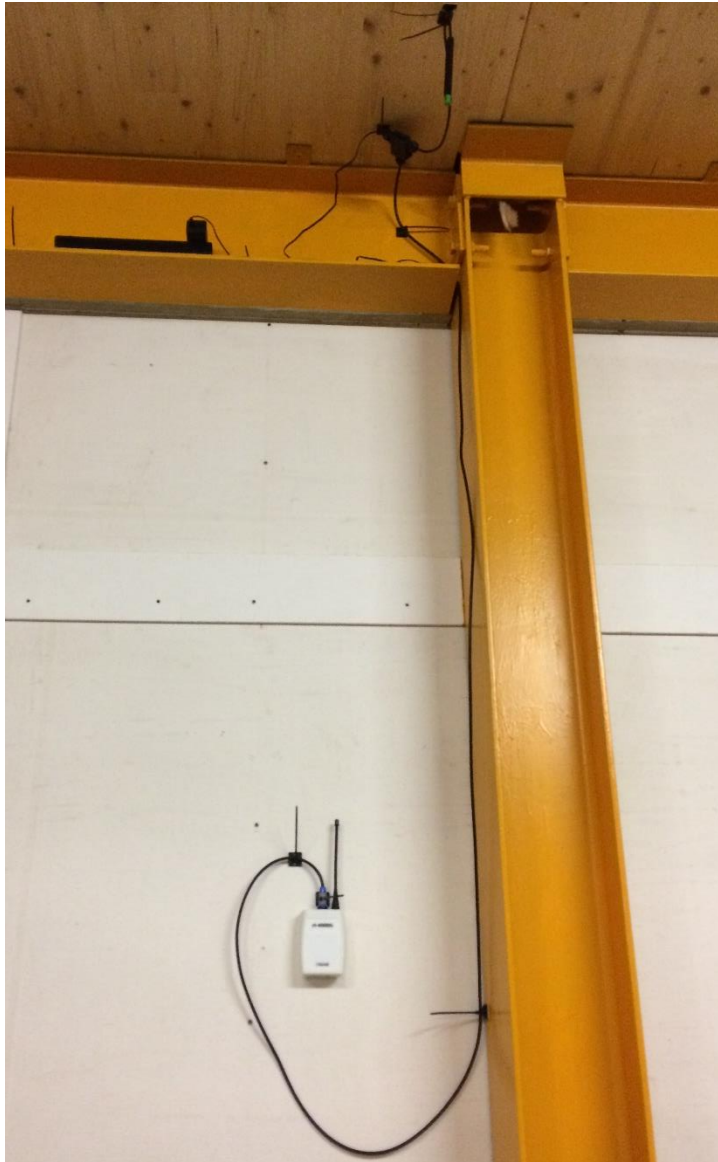
**Figure 4.50 Air flow meter & probe location, HMS 6**

The Hanwell Air Flow meter RL 4810 was installed in January 2018 in HMS 6 to verify and evaluate the operation of the air handling system by monitoring the air velocity in the storeroom. Data was assessed for ventilation and air velocity effects on RH control. The air flow probe J189-07 was initially suspended from the ceiling quite close to the air distribution supply grille in the north-west corner of the storeroom but then was moved half-way along the north end of the room to obtain more comprehensive monitoring data. The sensor was suspended from the ceiling in the same area as the median RH and temperature sensor (Figure 4.50) as this was one of the few areas of the storeroom that could be accessed without having to move carriages.
